UROLIFT[®]

Before and After Photos of the UroLift[®] Procedure

UroLift® System Procedure

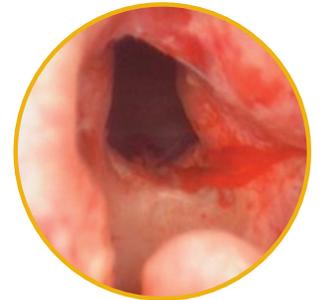
(Images courtesy of Dr. Peter Chin, Wollongong, NSW, Australia)

Pre-procedure

Post-procedure
